DEPARTMENT OF TRANSPORTATION

Quality Assurance and Source Inspection

Contract #: 04-0120F4Cty: SF/Ala Rte: 80 PM: 13.2/13.9File #: 69.28**WELDING INSPECTION REPORT****Resident Engineer:**Siegenthaler, Peter**Address:** 333 Burma Road**City:** Oakland, CA 94607**Report No:** WIR-023221**Date Inspected:** 27-Apr-2011**Project Name:** SAS Superstructure**OSM Arrival Time:** 1900**Prime Contractor:** American Bridge/Fluor Enterprises, a JV**OSM Departure Time:** 700**Contractor:** Zhenhua Port Machinery Company, Ltd (ZPMC), Changxing Island **Location:** Shanghai, China**CWI Name:** See below**CWI Present:** Yes No**Inspected CWI report:** Yes No N/A**Rod Oven in Use:** Yes No N/A**Electrode to specification:** Yes No N/A**Weld Procedures Followed:** Yes No N/A**Qualified Welders:** Yes No N/A**Verified Joint Fit-up:** Yes No N/A**Approved Drawings:** Yes No N/A**Approved WPS:** Yes No N/A**Delayed / Cancelled:** Yes No N/A**Bridge No:** 34-0006**Component:** OBG Components**Summary of Items Observed:**

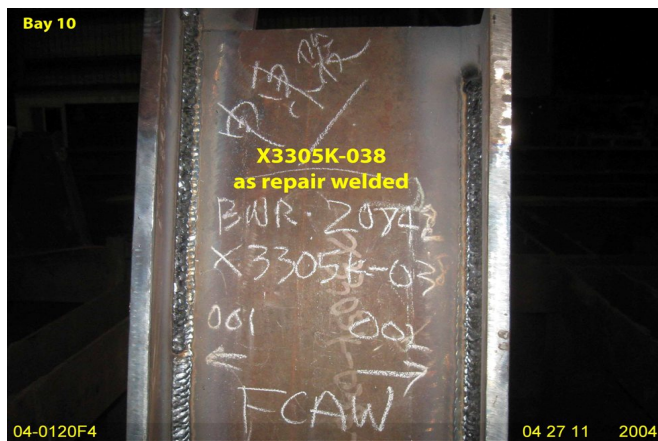
FCAW repair welding of weld joints X3305K-038-001, 002; X3305K-025-001, 002 located on PCMK OBG splice plate channel. Welder was identified as 054069. QC was identified as ZPMC CWI Li Jun (QC1). Also at this location and appearing to be monitoring the welding operation and recording data was ABF CWI Yang Yi Heng (ABF1). Weld variables recorded by QC1 appeared to comply with WPS-345-FCAW-3G(3F)-ESAB-repair as displayed on ZPMC Weld Repair Report B-WR20842 as presented to this QA Inspector and verbally identified by QC1. See photo below of weld joints X3305K-038-001, 002 after repair welding.

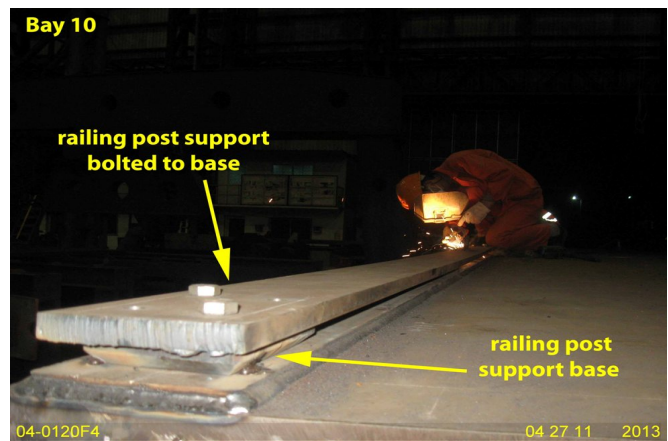
Fit-up and SMAW tack welding of railing post support base and conduit support located on PCMK OBG BK014, bike path. Welder was identified as 061938. QC was identified as QC1. Weld variables recorded by QC1 appeared to comply with WPS-B-P-2212 as verbally identified by QC1. See photo below of ZPMC welder 061938 tack welding one of the railing post support bases to the bike path deck.
